Re: City of Las Vegas Water Treatment Plant; Minor Industrial; SIC 4941; NPDES Compliance Evaluation Inspection; NPDES # NM0030341; June 4, 2018

NPDES Compliance Inspection Report

Compliance Evaluation Inspection City of Las Vegas Water Treatment Plant NPDES Permit No. NM0030341 Inspection Date: June 4, 2018 Further Explanations

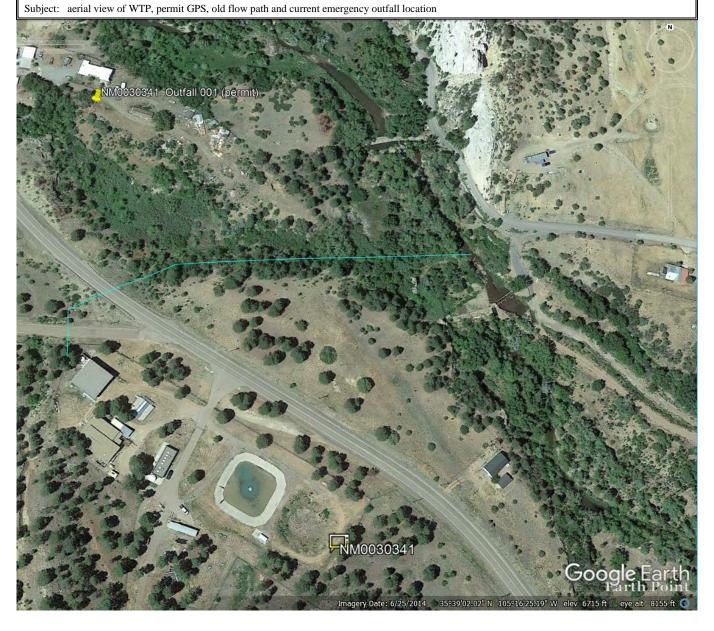
| NMED/SWQB Official Photograph Log Photo # 1 | | | | | | |

On Google Earth, the GPS location as described in the permit for Outfall 001 is located incorrectly across
the road(photo 1). The WTP facility used to discharge on the northwest side to a roadside ditch, changes
have been made to the facility and the current emergency overflow location is now located on the east
side of the facility. A specified location to obtain samples has not been established.

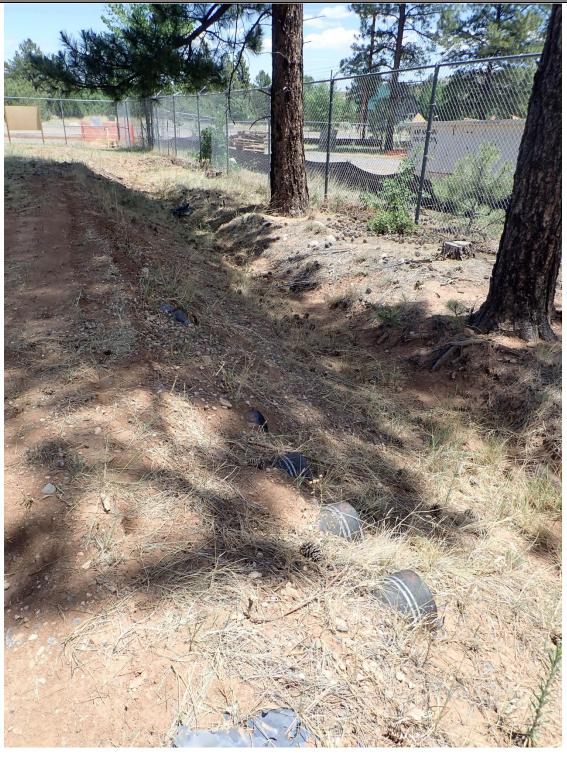
| NMED/SWQB Official Photograph Log Photo # 2 | | | | | | |

If the approximately 420,000 gallon lagoon were to overfill, an automated alarm will trigger when the lagoon reaches 2 feet below the overflow. The lagoon could then overflow to an unlined storage depression next to the waste lagoon. If the overflow basin were to overflow, it would discharge via three small pipes to an adjacent earthen drainage ditch and thence to the Gallinas River. There is no method to measure flows.

| NMED/SWQB Official Photograph Log Photo # 2 | | | | | | |
|---|---|---|--|--|--|--|
| Subject: Overflow pond outfall location | | | | | | |
